Mobile Intel® Celeron® Processor on .13 Micron Process in Micro-FCPGA Package

Specification Update

October 2004

Document Number: 251309-023

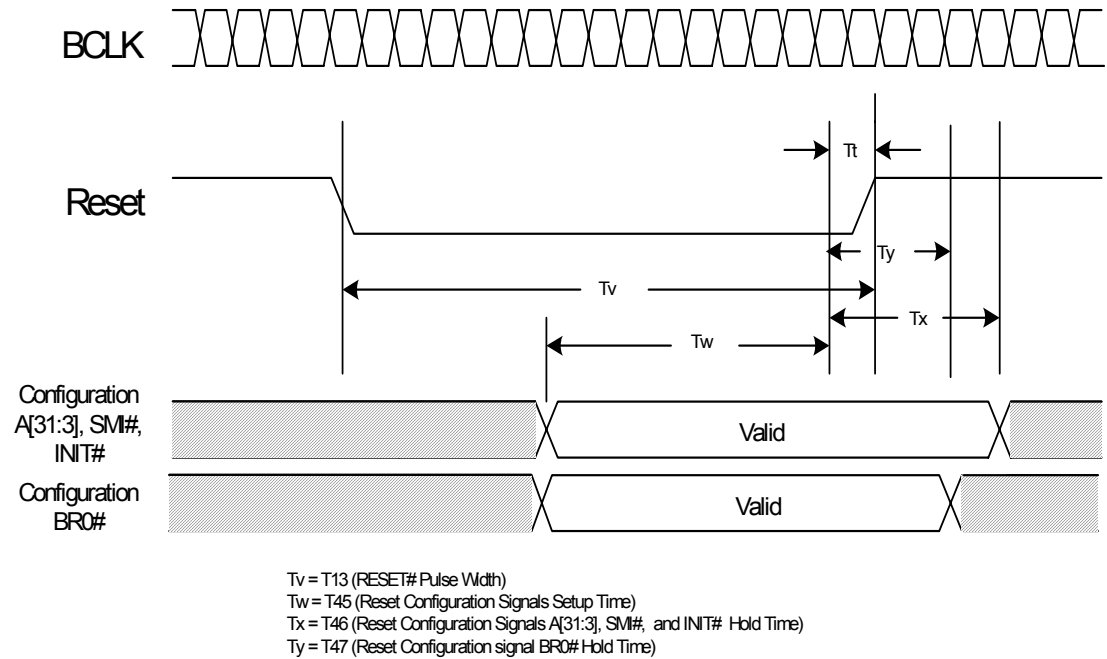
Figure 12. System Bus Reset and Configuration Timings

The BR0# maximum hold time has changed to 2 BCLKs. This change will be shown in the “System Bus AC Specifications (Reset Conditions)” table and “System Bus Reset and Configuration Timings” figure of the *Mobile Intel® Celeron® Processor on .13 Micron Process in Micro-FCPGA Package Datasheet*. This change will be incorporated in the next revision of the datasheet.

The following figure will be modified to reflect this change:
